# Property Damage Appraisers (PDA Miami, Fort Lauderdale)

Damage Assessed By: Orlando Fontela  
 Classification: Field

Type of Loss: Collision

Description: 2016 Freightliner M2  
 Type/Component: Truck  
 VIN: 1FVACWDUXGHHN3050  
 Mileage: 1  
 OEM/ALT: O  
 Color: RED

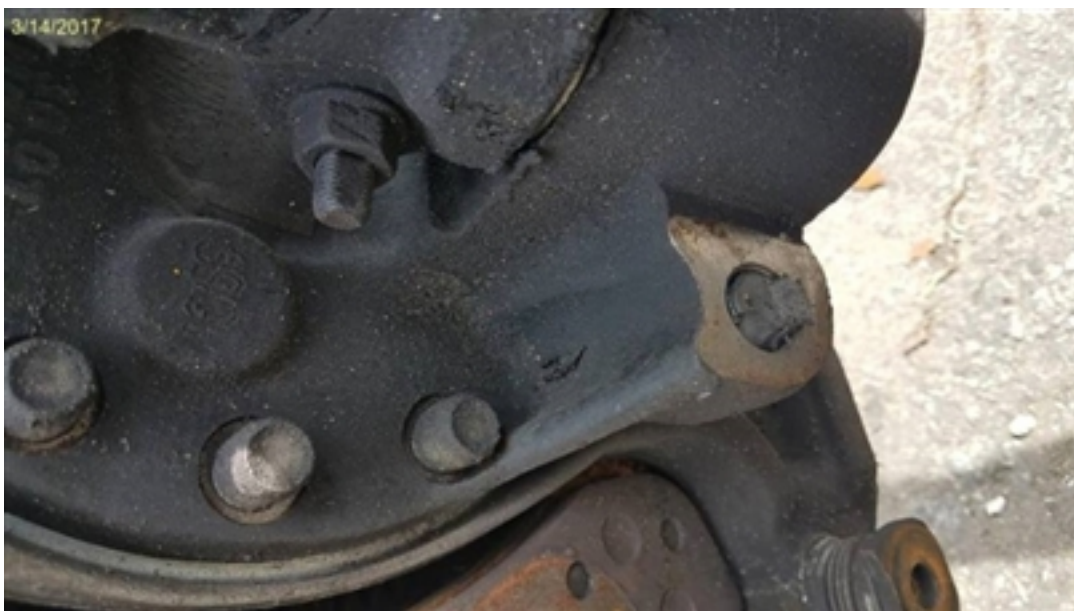
Document Name: 64 CALIPER SHEARED OFF.jpg

| 63 | 900500 | MCH* | REMOVE/REPLACE | Caliper, Brake L | | New | 175.16 | * 0.5* |

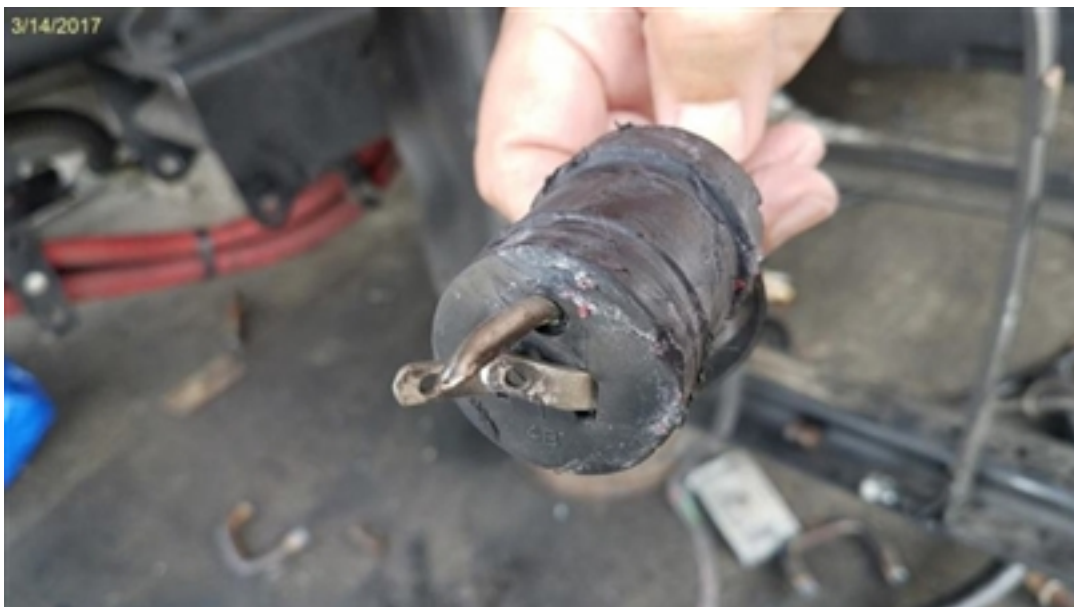
Document Name: 65 PLUG CONV DAMAGE.jpg

| 142 | 900500 | MCH* | REMOVE/REPLACE | Plug Harness, Converter | New | 52.50 | * | 1.2* |
