Delray Beach Golf Club

Prepared for: The City of Delray Beach

March 23, 2016

SANFORD
GOLF DESIGN

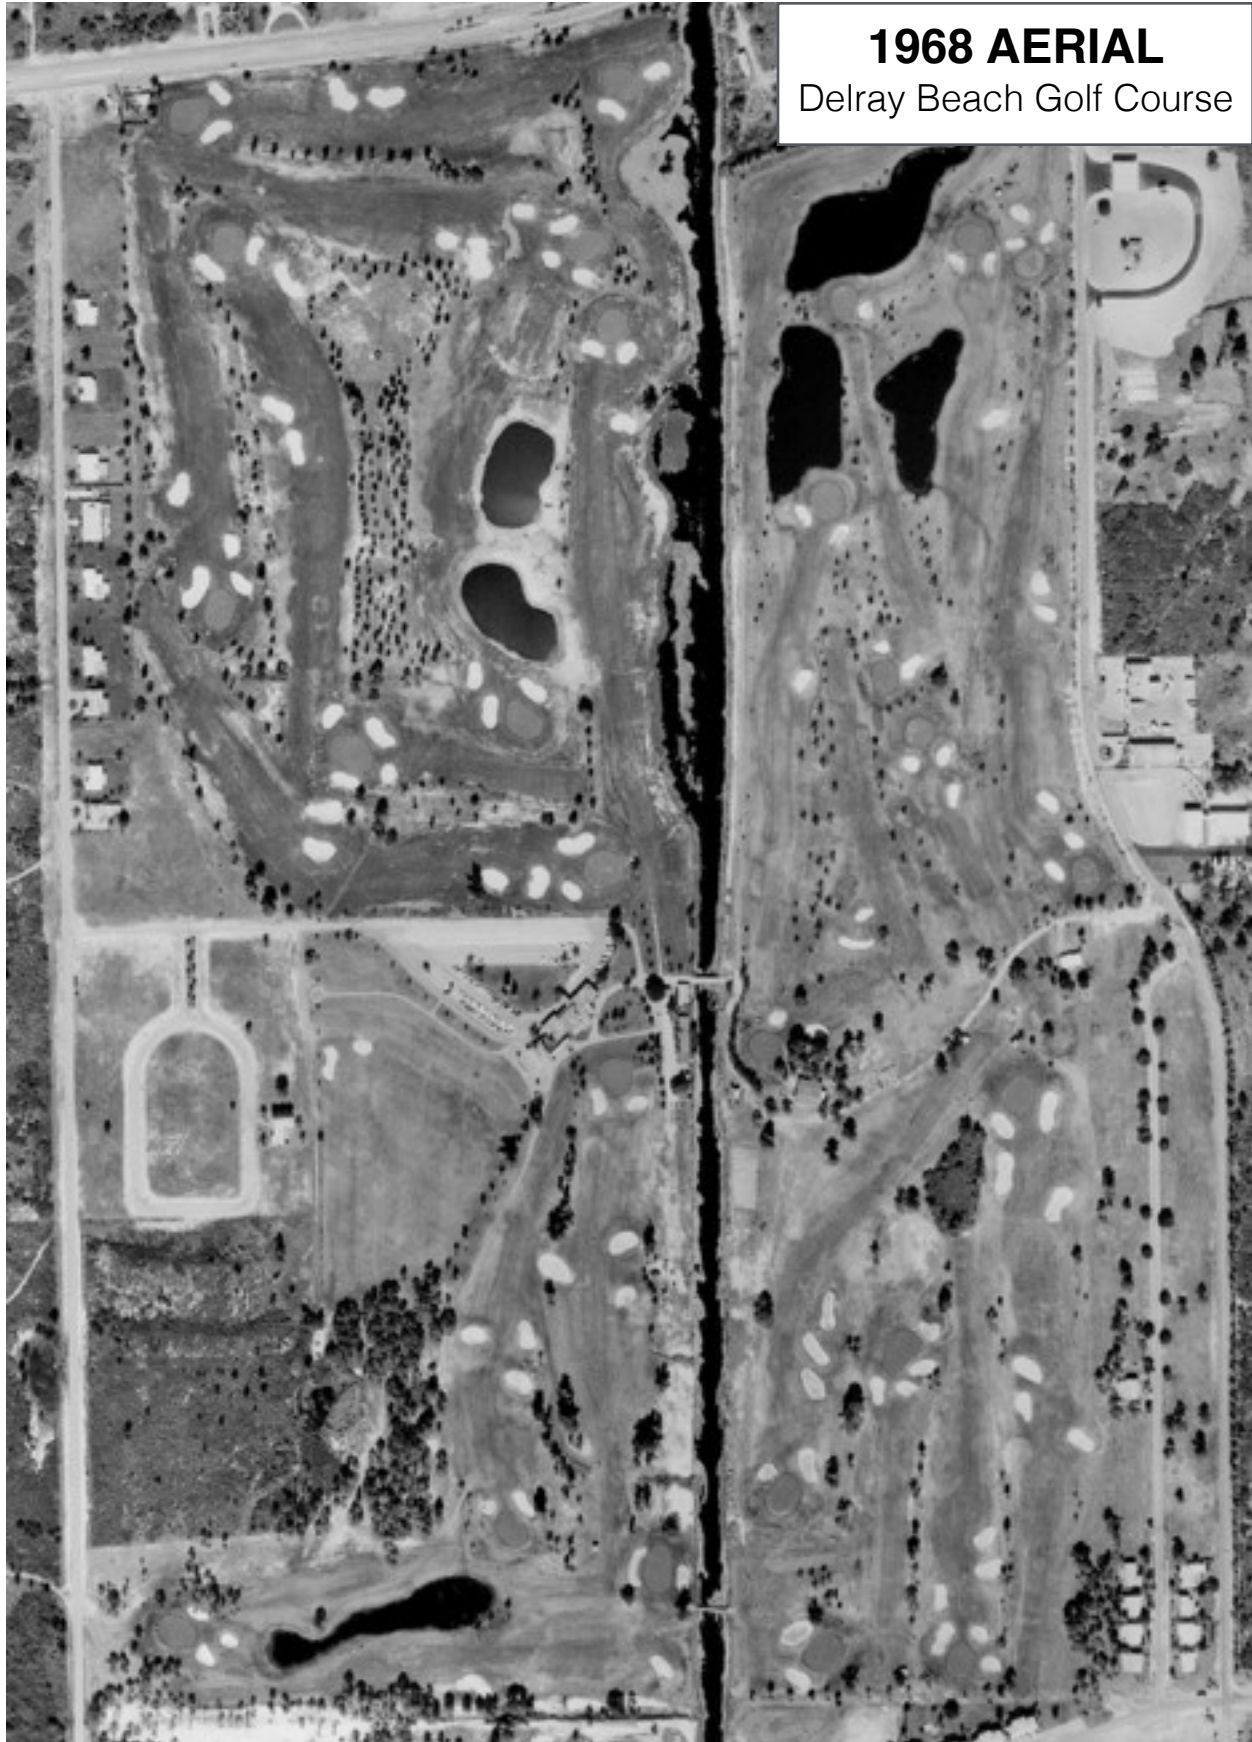
1968 AERIAL
Delray Beach Golf Course

Both Ross and Wilson 9-holes under went major changes and a third 9-holes completed.

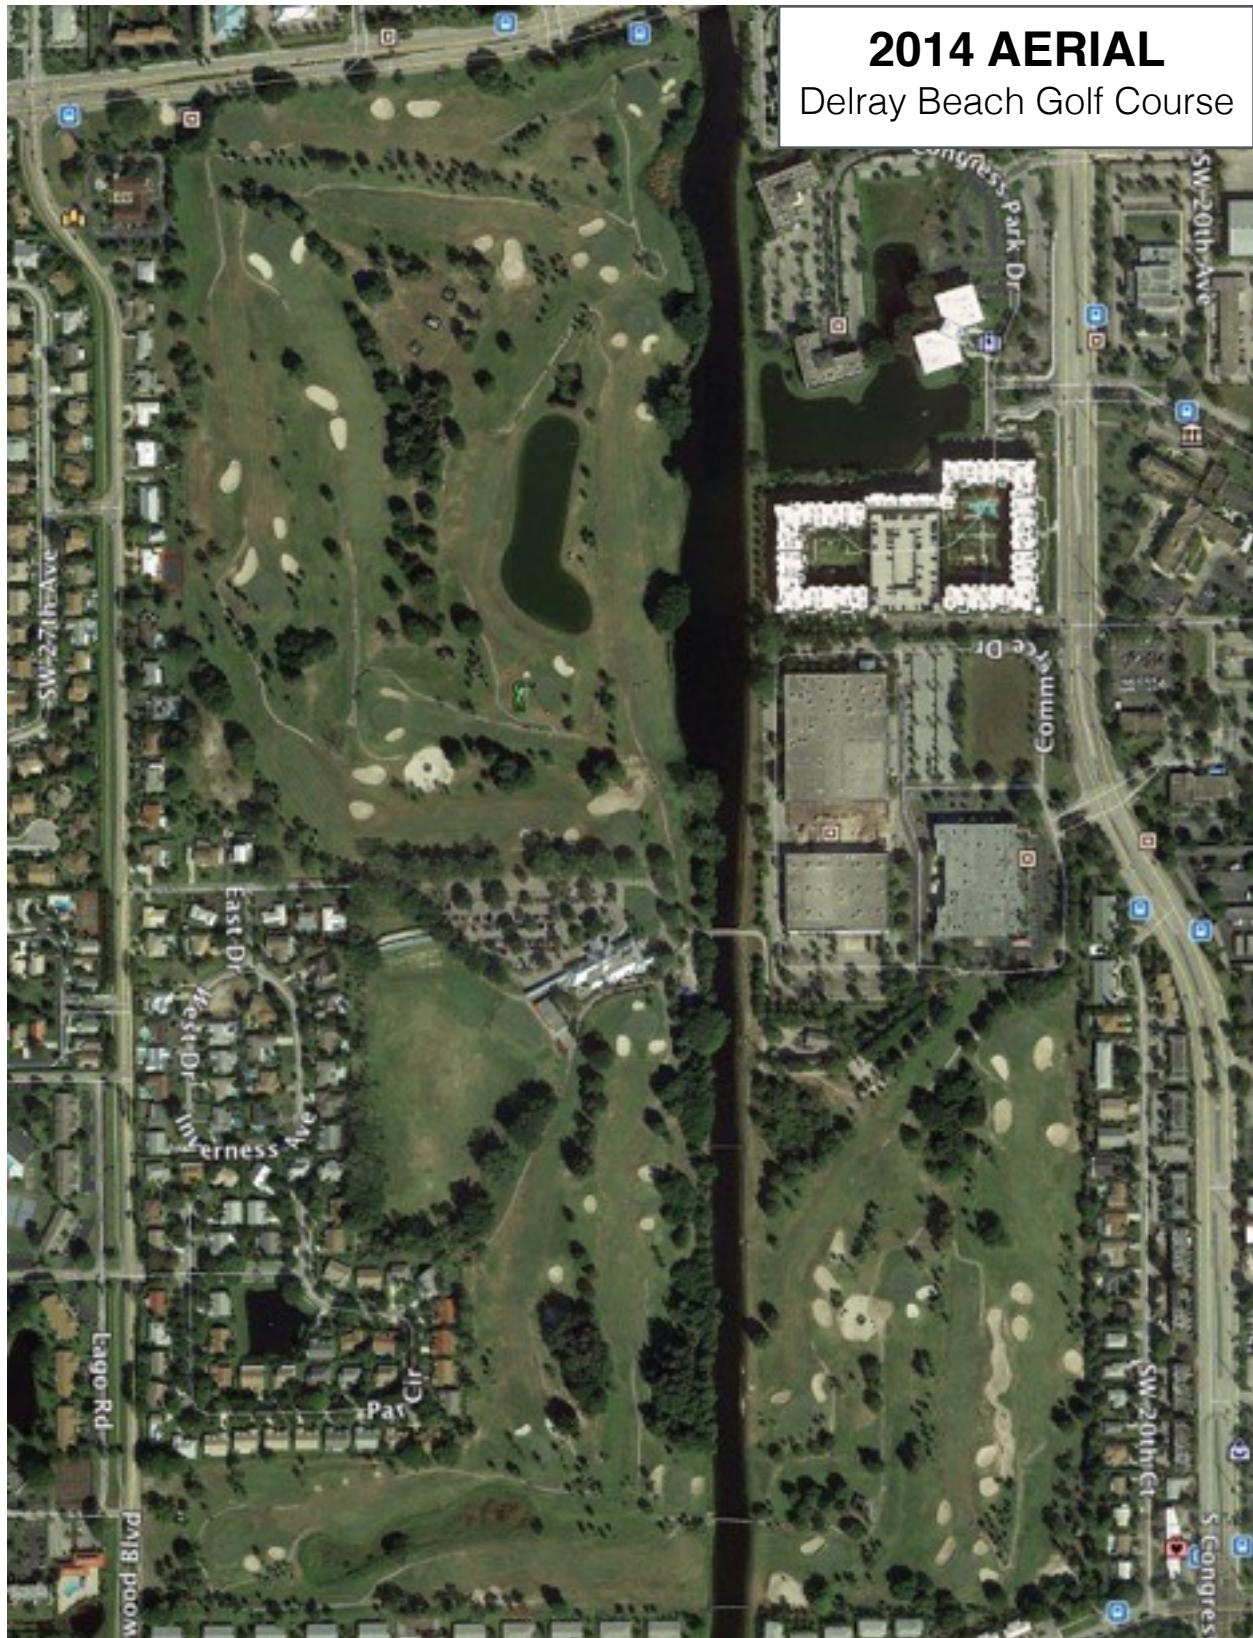
2014 AERIAL
Delray Beach Golf Course

More recent aerial reveals changes since 1968 including additional bunkers, surrounding development, transformation of #11 pond and heavily treed areas.

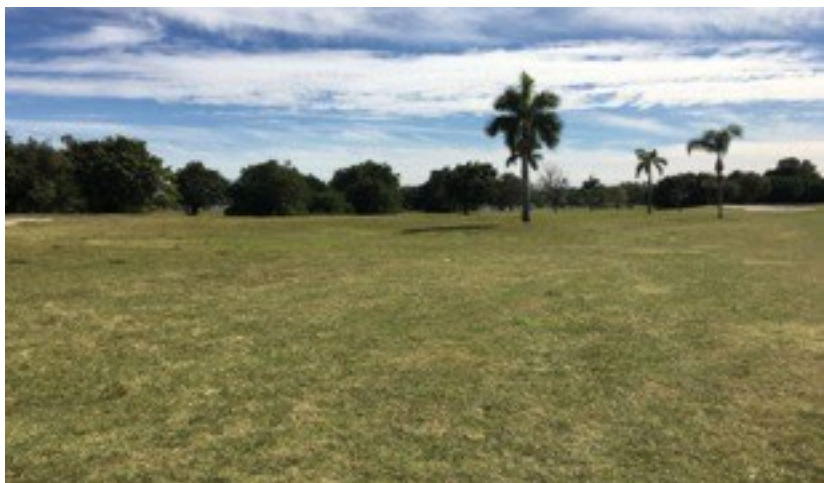
Large area between holes 4 & 8 that is currently being maintained as rough.

There is also an opportunity to reduce maintained turf area in the deep rough, thus limiting the irrigated area, fertilizers and pesticide use. The unirrigated areas would be supplemented with native ground cover.

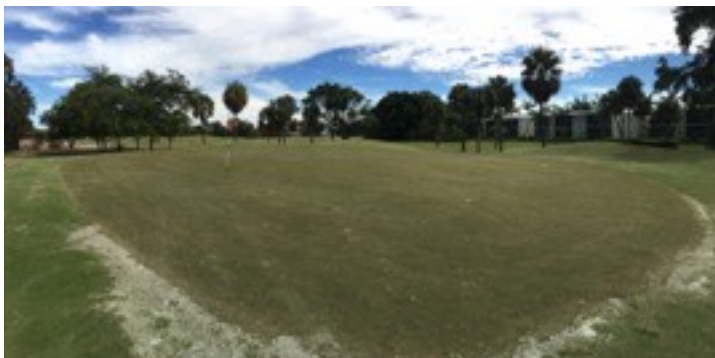
It is evident that the greens have shrunk and been flattened out through the years. Our preliminary takeoffs of the rebuilt greens (Google Earth 2005 image) and the current greens (2014 aerial provided by surveyor) indicate a +/-5% decrease in green sizes. The current greens average 5,000sf. This decrease is normal due to the encroachment of the turfgrass around the greens and routine mowing.

Greens have become smaller and flatter over time.

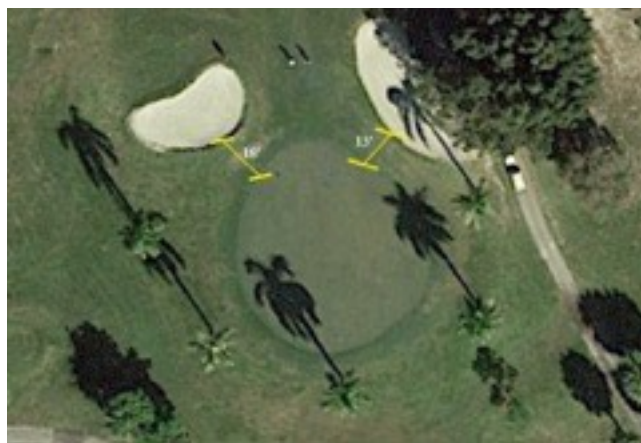
Hole 1 green complex with bunker edges far away (+/-15') from green creates a difficult recovery for the average golfer.

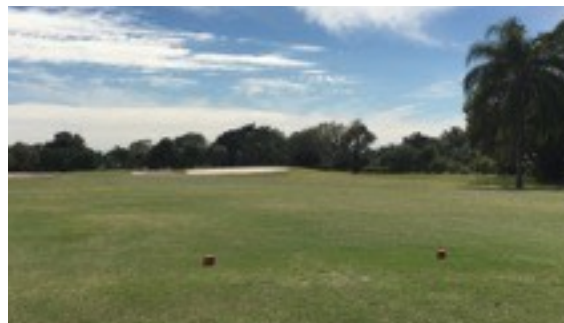
As shown in the Life Cycle Chart tees have a life expectancy of 15 to 20 years. Most of the tees at Delray Beach Golf Course are uneven and require leveling and expansion. Currently there is not enough tee space (+/-90,000sf) to accommodate the volume of play (250 to 275 rounds per day). Some holes may benefit from the addition of a forward tee for higher handicap players and beginners.

Tee markers in fairway currently being used as the forward tee.

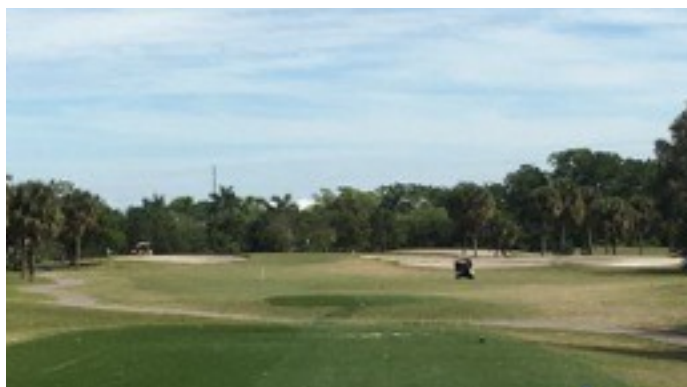
Both Donald Ross and Dick Wilson understood that bunkers were a critical component to any golf course. Currently Delray Beach Golf Course has a total of 72 bunkers totaling 188,200sf, far exceeding industry average (80,000sf), resulting in greater maintenance costs. It is recommended that bunker sizes be reduced and locations/shape be

Oversized fairway bunkers reduce fairway widths making it more difficult for the average golfer and requires additional cost to maintain.

revised to reflect the original architects' strategic intent.

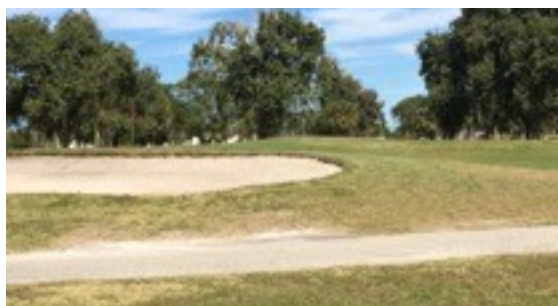
Typical greenside bunker that is higher than the putting surface.

Green side bunkers tend to be higher than the putting surface. This is not a common design feature for a Ross or a Wilson bunker. It is assumed that over time sand has built up on the greenside edge of these bunkers. Green complexes should be renovated so the bunkers are more in keeping with the original architect's style.

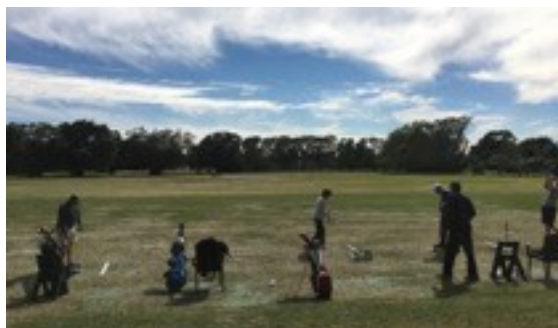
Practicing has become more popular in the last 10 years and can be a positive revenue generator for this facility. The existing range tee is undersized and during the winter months when the turfgrass isn't growing as much the tee surface is heavily damaged. The range is undersized with a distance of 250 yards from the front of the tee box to the back of the range and 195 yards along the east side of the range. Pushing the range tee back (north) and reorienting the range away from the homes will be explored in the Master Plan design.

Practice range tee during season. Due to high volume and slow turfgrass growth the tee sustains have damage.

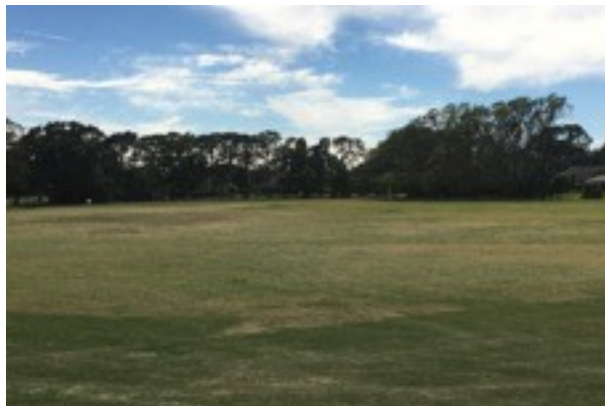
Practice range lacks definition and targets.

Golfers like to practice hitting shots to defined target, which the practice range lacks. Target greens with varying lengths should be added to the range. These target greens could be positioned to create a short course that could be used to help grow the game and host fun events.

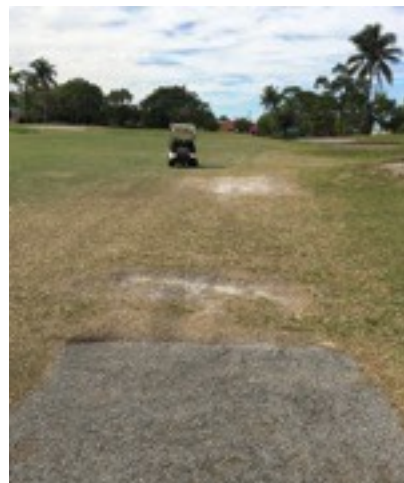
Noncontinuous cart paths have created difficult conditions to grow turf due to compaction, wear and tear.

The existing cart paths are approximately six feet (6') wide, not continuous and asphalt with a typical life span of 5 to 10 years. As a minimum the cart paths should be eight feet (8') wide and new continuous “soft” cart paths considered throughout the golf course. To provide an enhanced level of aesthetics the material for the “soft” cart paths should be crushed concrete or Coquina like material. Some of the areas with unhealthy turf due to shade issues can be combined into this concept. Also, there are several areas around the golf course where circulation of carts and maintenance equipment can be improved by re-routing the cart paths and with the addition new paths.

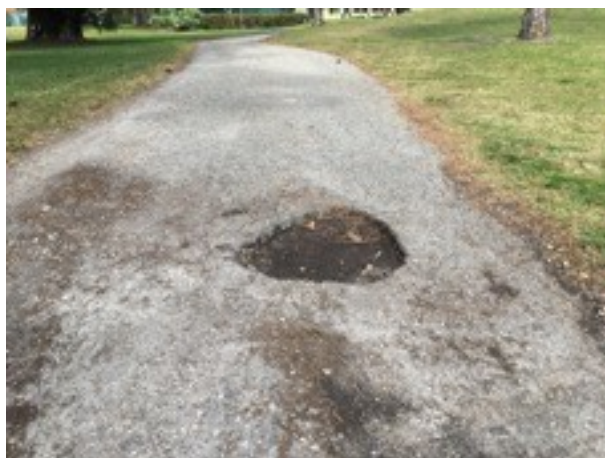
Typical asphalt cart path with pot hole.

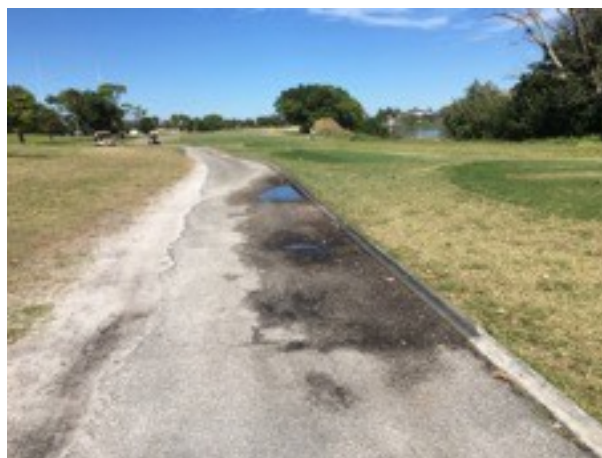
Asphalt cart path with worn edges, pot holes and holding water.

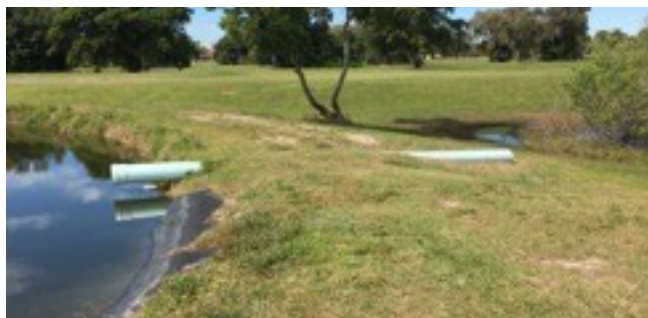
Exposed pond liner.

The liner is 13 years old and is less than halfway through its life expectancy, however the liner has become exposed and subject UV light which can greatly reduce its life expectancy. Lake banks need to be repaired so liner is not exposed.

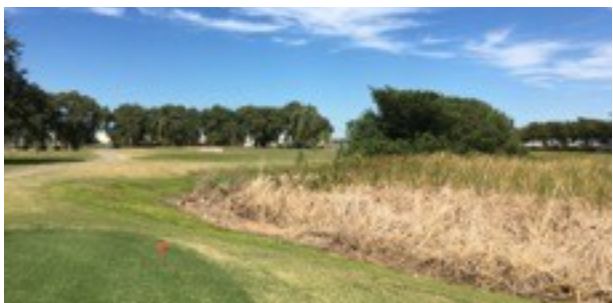
Vegetation that has filled a portion of the canal on hole 6.

Where the canal cuts into hole 6 has become overgrown non-desirable aquatics. This area should be cleaned out and if possible filled in to eliminate the stagnation that occurred in the past. Canal edge should be reviewed by an engineer and recommendations made accordingly.

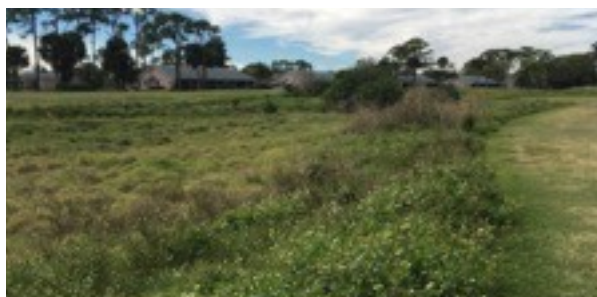
In 1995 there was a pond in between holes 11 and 12 but over time surrounding drainage patterns changed, the City wells have drawn down the surrounding water table and the pond has become an unsightly/overgrown dry retention area. The former pond should be reviewed by an engineer and redesigned to meet current storage requirements.

Former pond on hole 11.

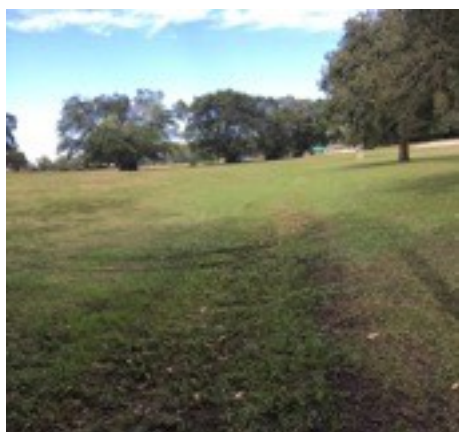
Area of poor drainage on hole 10.

From our initial site evaluation, it appears most of the golf course is built in sandy soils common to a South Florida, but the portions of holes 10, 11 and 12 tend to be higher in organic material and heavier soil. The original drainage concept was raised tees, fairways, greens to surface drain runoff into out-of-play areas. These poorly drained areas should be considered for plating with 6" of sandy material and reshaped to surface drain to a series of catch basins to maintain healthy turfgrass and dryer/more playable conditions.

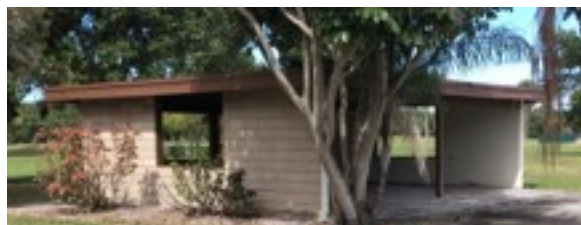
Existing rain shelter on hole 13.

The on course shelters are old and dilapidated. It is recommended that these structures be removed and the existing comfort stations be retrofitted to have a dual purpose as a rain shelter.

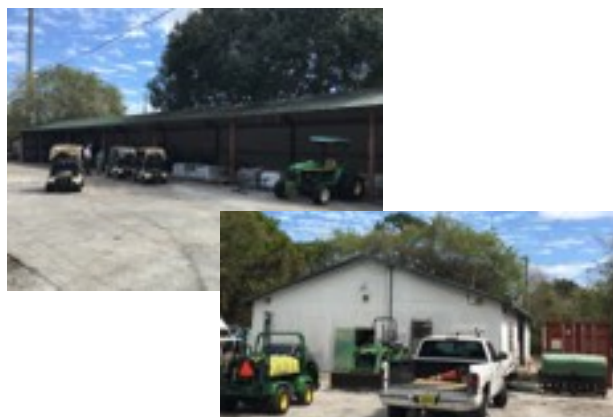
The existing maintenance facility is antiquated and undersized. The current delivery process is difficult and inefficient. Maintenance deliveries are in conflict with food and beverage deliveries to the clubhouse and often times materials have to be staged at the clubhouse because delivery trucks can't traverse the bridge/road to the maintenance facility, creating an undesirable situation and operational issues around the clubhouse. The existing structure should be razed and entire facility redesigned to accommodate a new building, chemical/fertilizer storage, soil bins, wash down area, parking, proper access for deliveries, keep operations off the canal bank, fueling, etc. A typical modern maintenance facility requires +/-1.5ac. (See Burrows report for more information)

Existing maintenance building and storage cover.

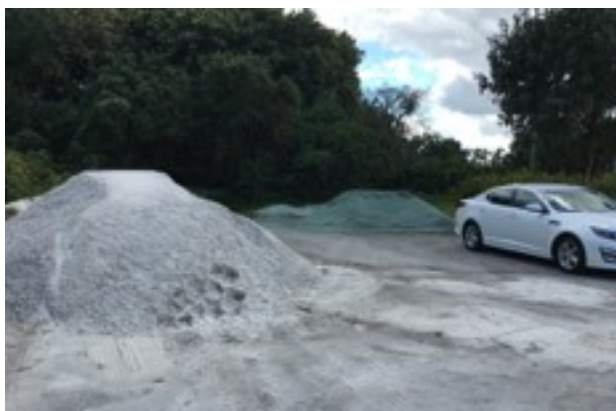
Materials staged at the clubhouse.

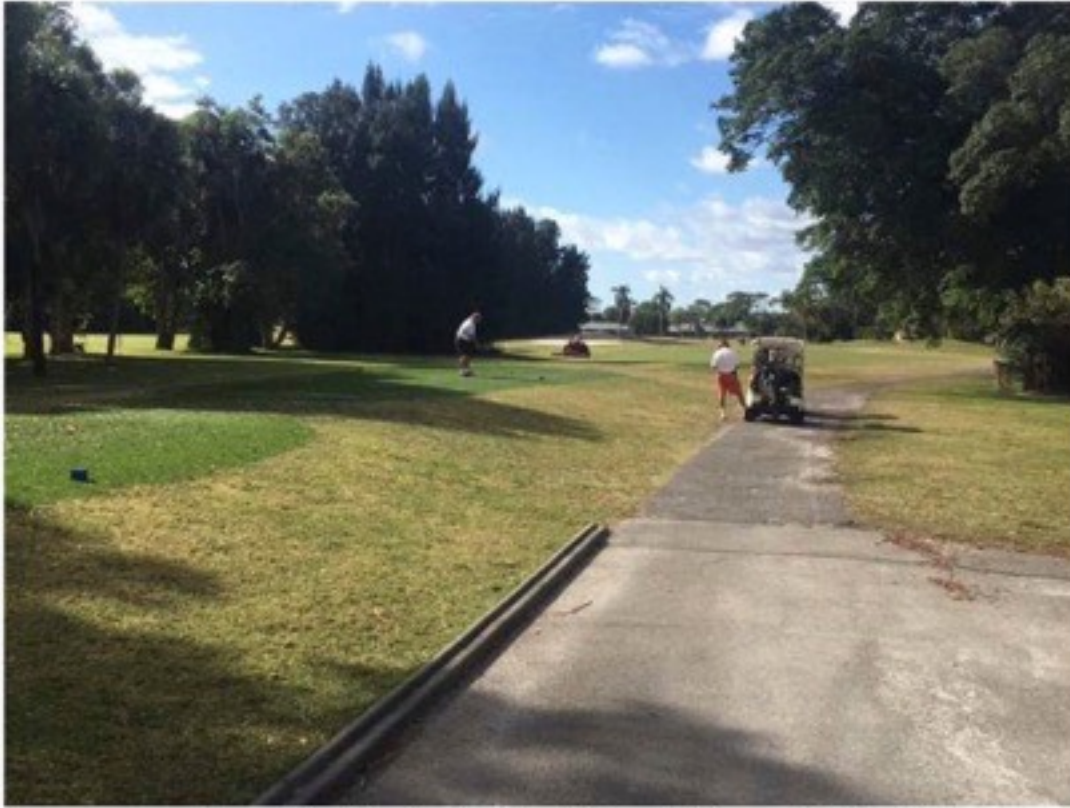
Tee box was overseeded and is doing better. Cart Path not being maintained throughout course.

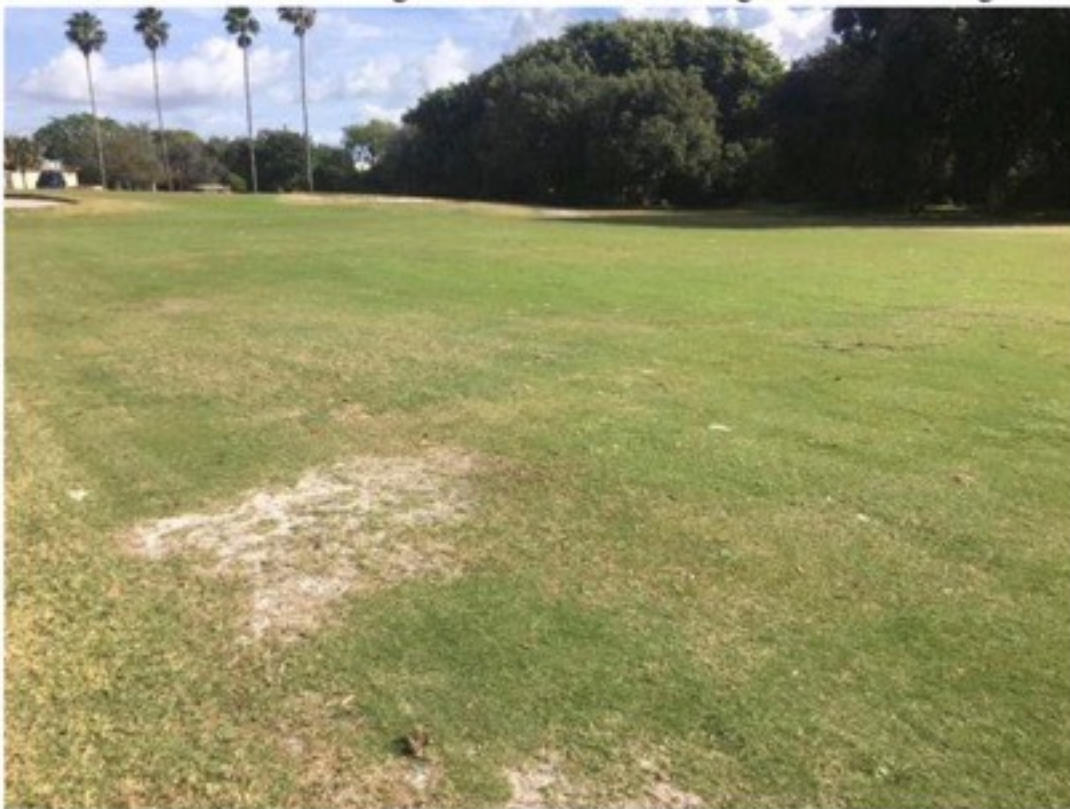
A lot of bare areas noticed throughout roughs.

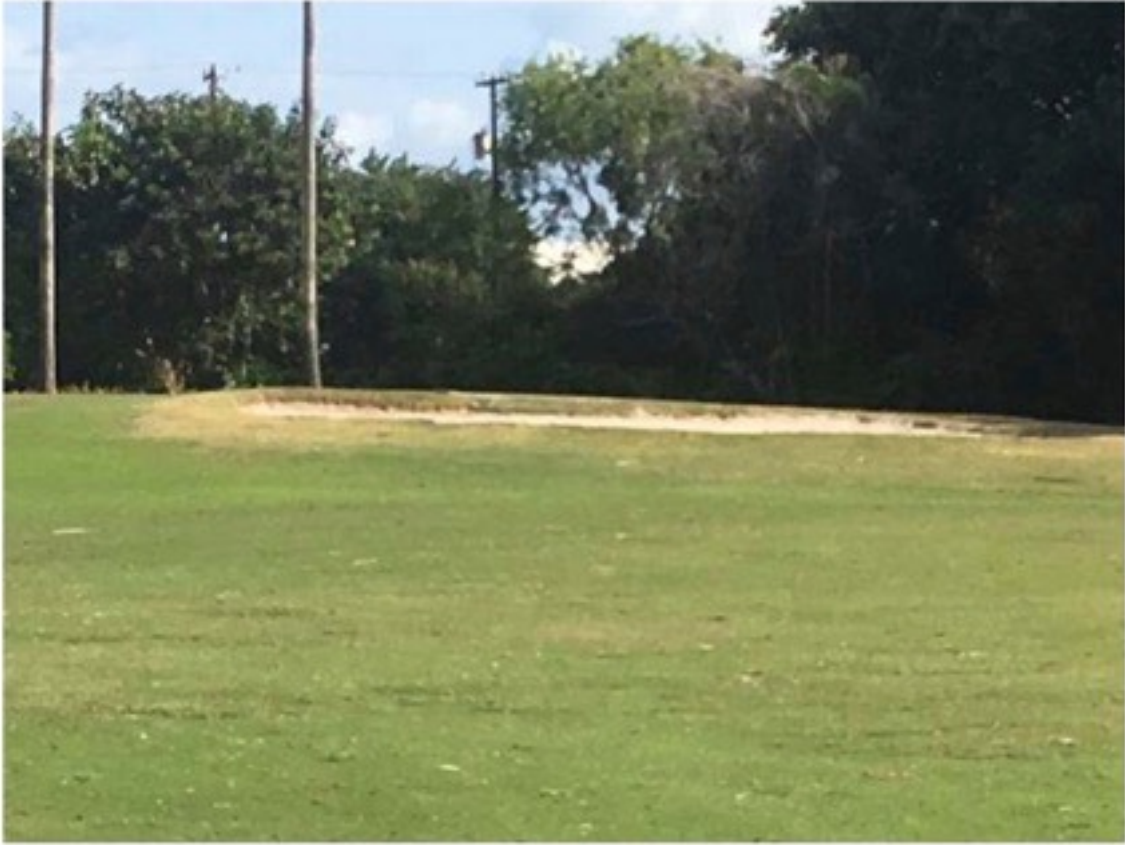
Bunker faces have old, thin turf.

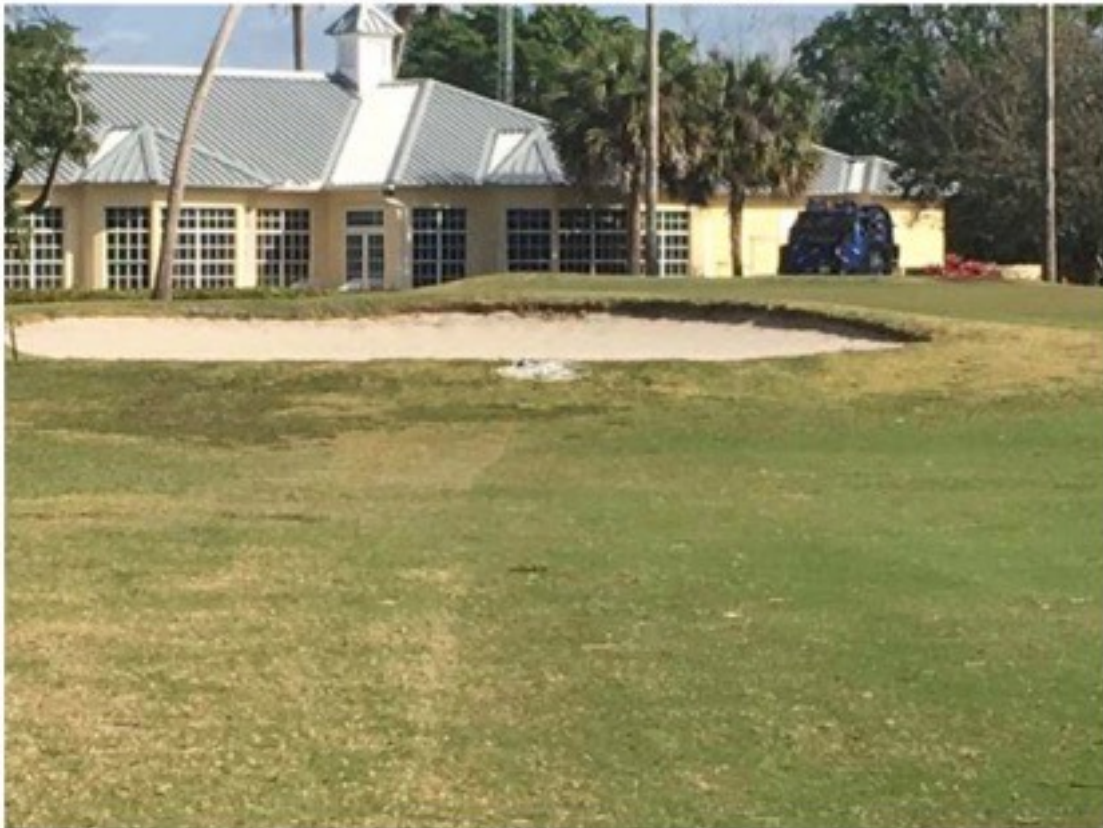
Bunker grass faces are old

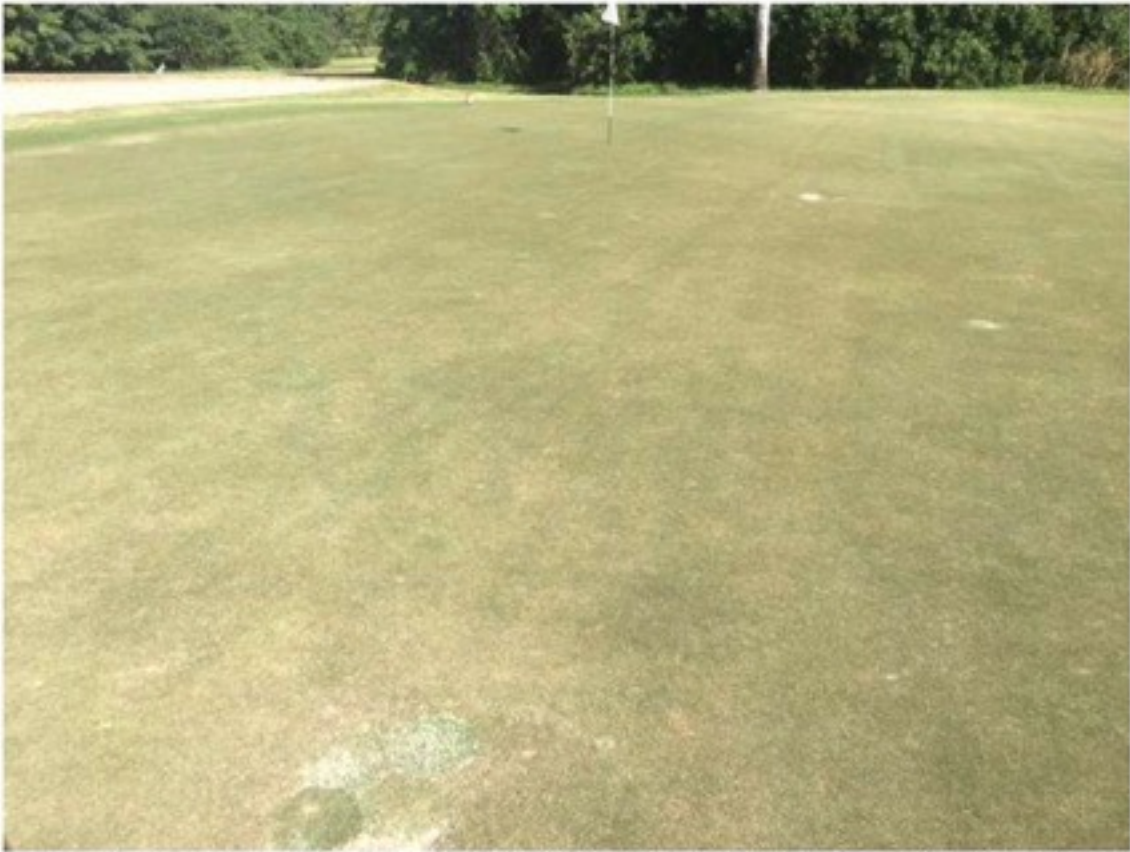
Greens surfaces, as stated in report, are being maintained but have contaminated grasses.

- 1) **Greens:** Because of the age of the greens and amount of contaminated areas of the greens surfaces, it is recommended that greens be re-grassed or a total greens renovation. Irrigation is full circle because of this, the surrounds get too much water and are staying wet. Part circle heads should be added for proper coverage.

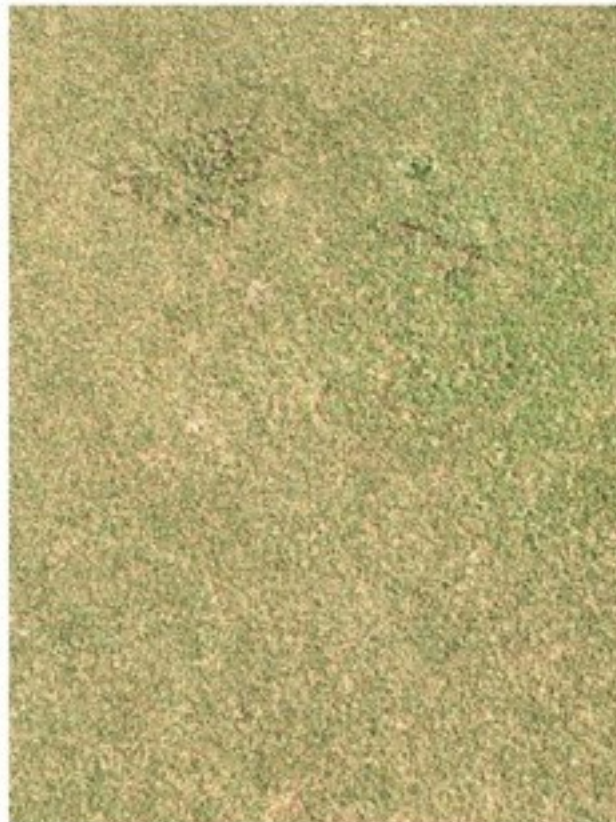
Greens surface has contaminated grasses.

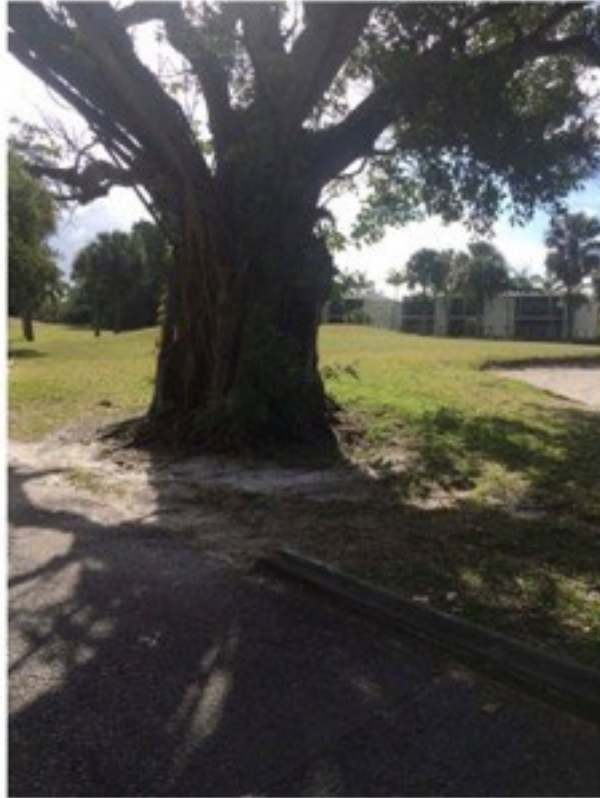
Cart path not being maintained. A lot of shade.

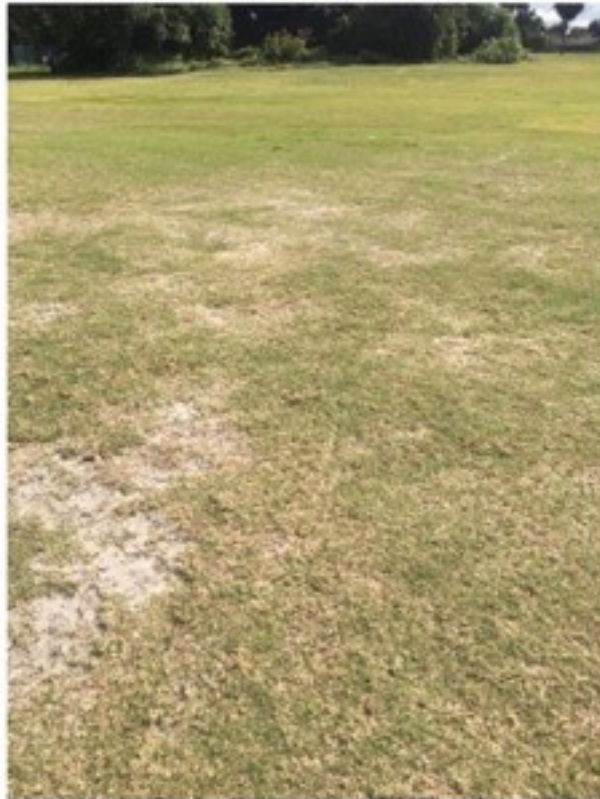
- 3) **Fairways:** The fairways at Delray Beach looked weak, thin, and off color during both visits. Weeds are seen throughout fairways and roughs. Many off types of Bermuda grass are seen throughout fairway and roughs. This is very common on older courses in Florida. Maintaining off type Bermuda grasses is challenging because it acts different throughout the year depending on weather conditions, fertility programs, culture programs, etc. Even with increased fertility, off types still become weak and thin faster during the fall and winters months due to lack of sunlight. **Recommendations:** Re-grass fairways and roughs. Today there are newer hybrid Bermuda grasses available.

Fairway has a lot of thin patches.

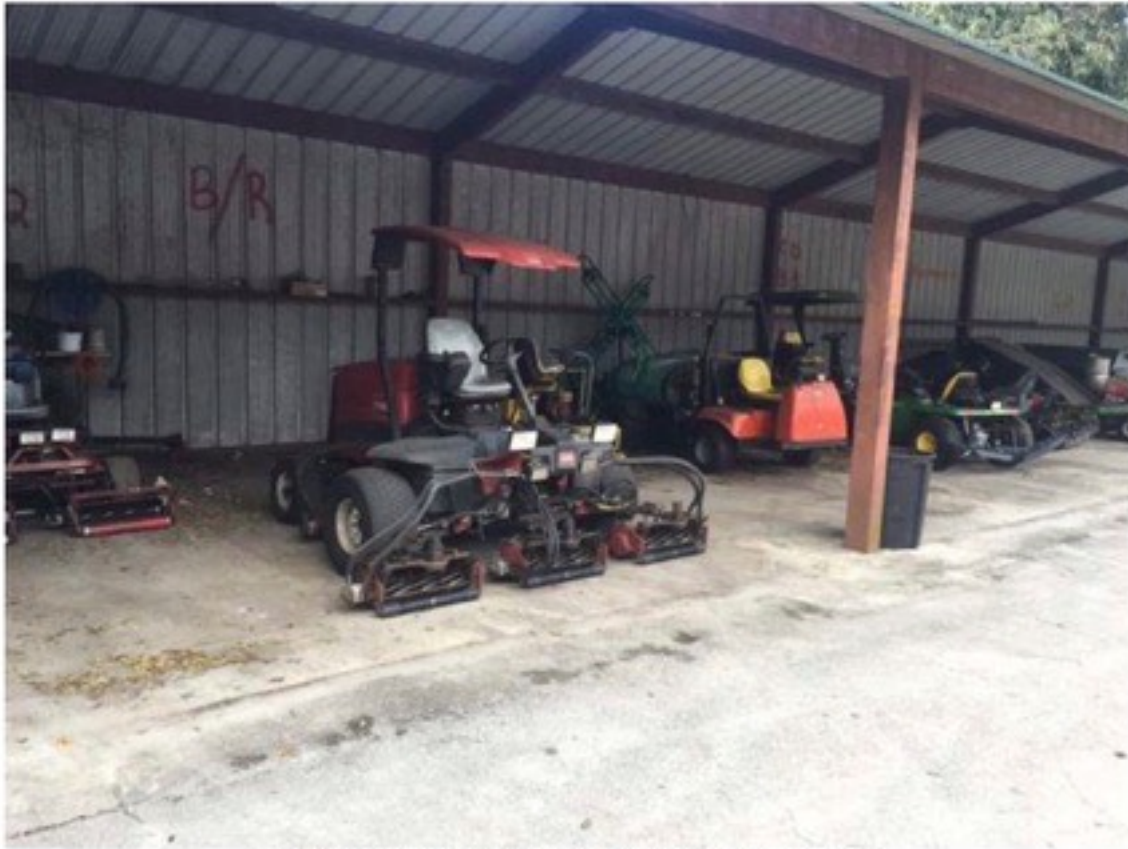
Equipment being stored outside under cover.

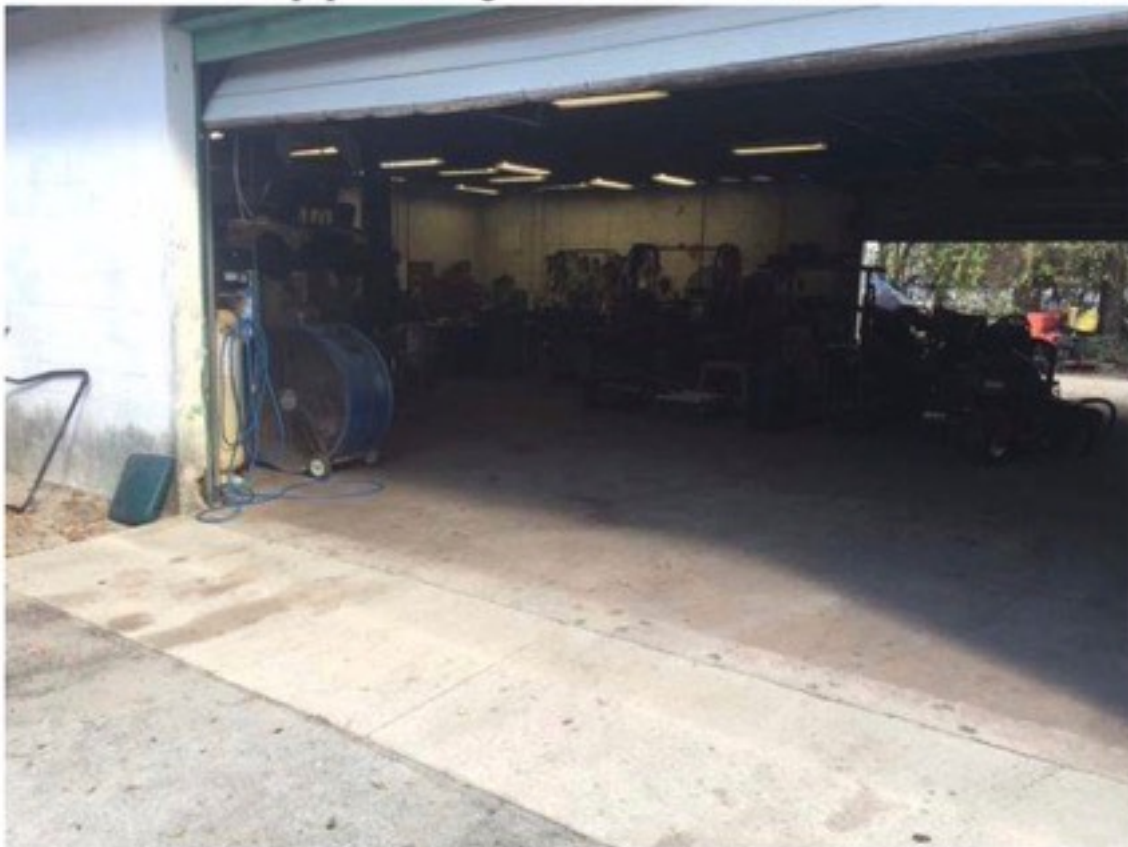
Maintenance only has small area to work in.
