# CITY OF DELRAY BEACH

**SUBJECT:** Recommendation for Repair of Roof and Building Exterior of City Hall and the Community Center

## City Hall & Community Center Inspection

Prepared By  
Robert Moses

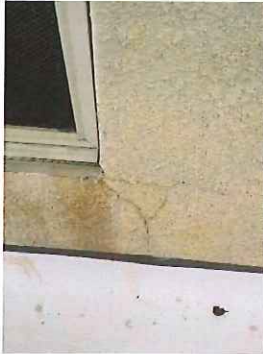
**Photo 1**

Exterior cracks on the stucco surface. Signs of water intrusion.

Action Year:	2016
Square Footage:	21,017	Expected Life Years:	7
Budget:	\$2.00		
Estimated cost is \$2.00-\$3.00 sqft for stucco repairs and full exterior coating.

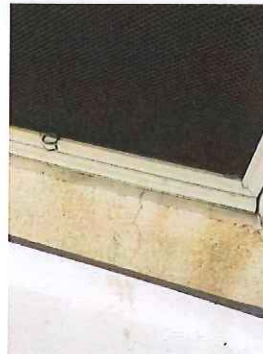
**Photo 2**

Exterior cracks under the window frame.

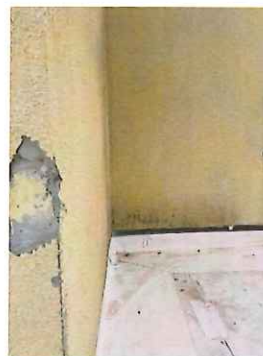
**Photo 4**

Severe damage to the building exterior.

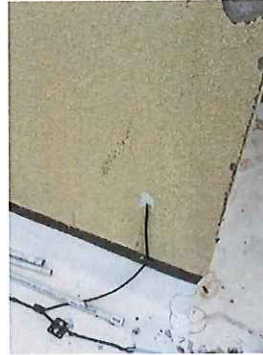
**Photo 6**

Cracking along the edge of the exterior.

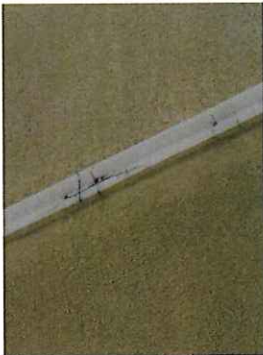
**Photo 7**

Exterior cracks on the exterior stucco.

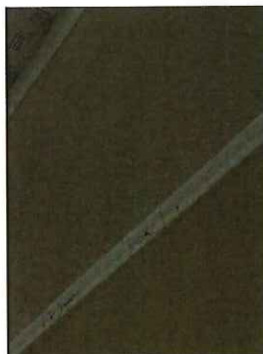
**Photo 9**

EIFS damage.

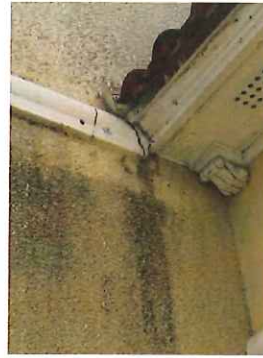
**Photo 12**

EIFS and stucco damage.

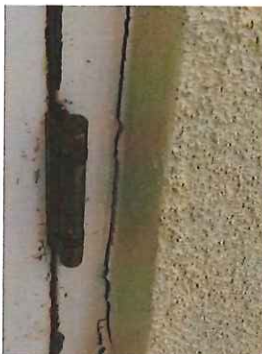
**Photo 15**

Sealant failure around the penthouse door.

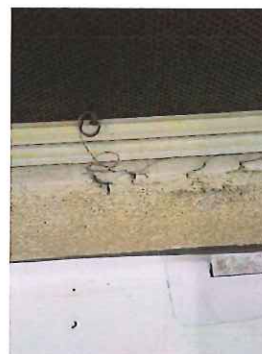
**Photo 16**

Exterior stucco failure.

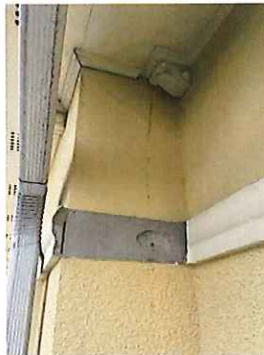
**Photo 19**

Exterior vertical cracking.

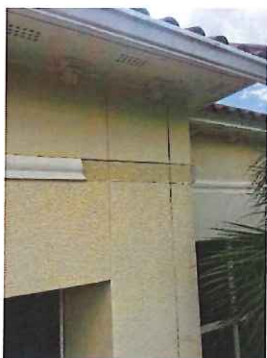
**Photo 23**

Adhesive failure.

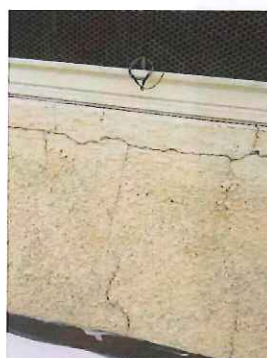
**Photo 26**

Coating failure.

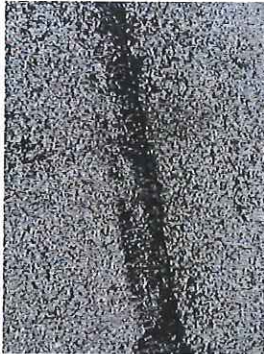
**Photo 1**

**Blisters:** Soft spongy pockets or swellings in the roofing material. They occur between layers of felt or between the roof membrane and substrate. Air or moisture vapor entrapped within a blister expands as the roof and outside air temperatures rise. This results in sufficient pressure to push the roofing felts upwards and apart. Blisters may be ruptured by roof traffic, expanding frozen water, or hail (especially during colder weather). Some blisters may become so large as to affect drainage, which may then cause ponding water. Laps could also be pulled apart, resulting in leakage. A ruptured blister will immediately allow water to penetrate and damage the roof system.

Action Year:	2016
Square Footage:	1,027	Expected Life Years:	25
Budget Range:	\$15,405.00 - \$19,513.00		
Complete replacement is necessary. The roof will need to be removed down the to the deck and replaced. Estimated budget is \$15-\$19sqft. This variation depends on on the system design of 20-30yr warranty.

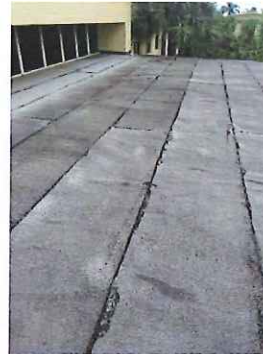
**Photo 2**

Excessive blisters over the entire roof surface. Possible installation of the membrane in below temperature asphalt.

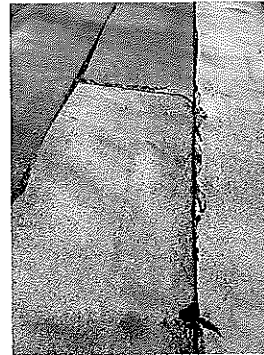
**Photo 6**

**Blisters:** Soft spongy pockets or swellings in the roofing material. They occur between layers of felt or between the roof membrane and substrate. Air or moisture vapor entrapped within a blister expands as the roof and outside air temperatures rise. This results in sufficient pressure to push the roofing felts upwards and apart. Blisters may be ruptured by roof traffic, expanding frozen water, or hail (especially during colder weather). Some blisters may become so large as to affect drainage, which may then cause ponding water. Laps could also be pulled apart, resulting in leakage. A ruptured blister will immediately allow water to penetrate and damage the roof system.

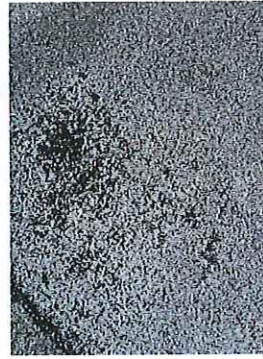
**Photo 10**

**Bare or Exposed Felts:** Weathering causes the roofs surfacing materials to oxidize and wear away after a period of time. Loss of protection from the surfacing material results in accelerated deterioration of the primary waterpoofer asphalt, along with the systems reinforcement plies which provide the strength for the system. Heat and UV rays dry out unprotected asphalt which then leave the bare reinforcement plies exposed to the elements. The exposed reinforcement will begin to absorb and wick moisture into the built up layers of the roof system. This condition leads to accelerated damage via blisters and interlayer delamination. Roof system damage occurs when these weakened areas of the roof system are affected by thermal shock, typical roof traffic and normal seasonal conditions.

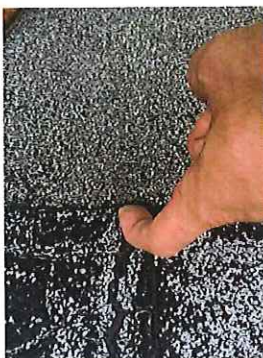
**Photo 11**

Failed seam. Insufficient bleed out.

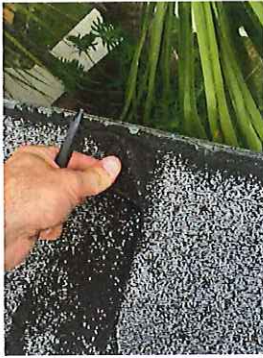
**Photo 16**

Insufficient bleed out of asphalt. Failed seam.

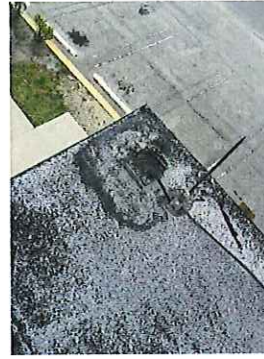
**Photo 17**

Failed seam.

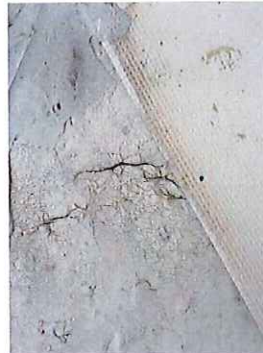
**Photo 27**

Failed membrane.

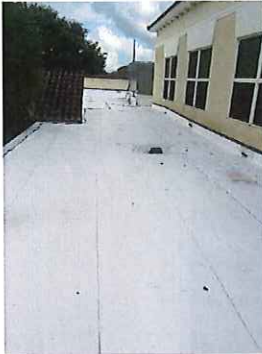
**Photo 1**

Overview of roof section showing multiple patches.

The single ply roof system has failed. The membrane has surpassed its life expectancy and is failing along all the seams and in the field. An immediate replacement is needed. Estimated budget is \$15-\$19/sqft. This variation depends on the system design of 20-30yr warranty.

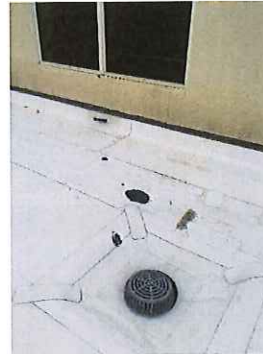
**Photo 2**

Excessive patches on the single ply membrane.

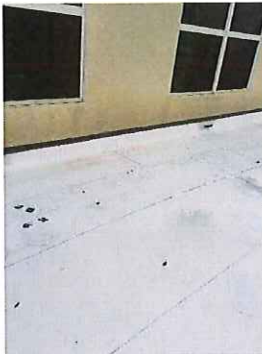
**Photo 3**

Multiple patches and seam failure.

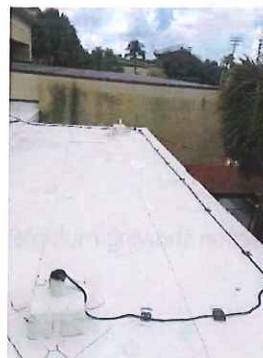
**Photo 8**

Membrane failure. The membrane has reached its life expectancy and has split wide open allowing water to penetrate the interior roofing structure and roof deck.

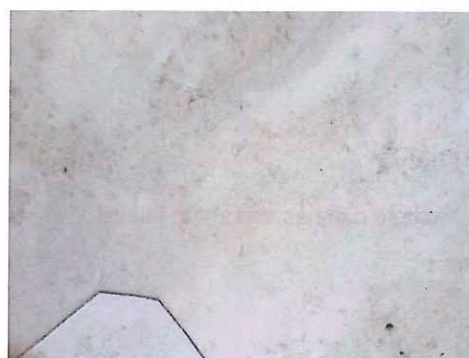
**Photo 10**

Membrane failure.

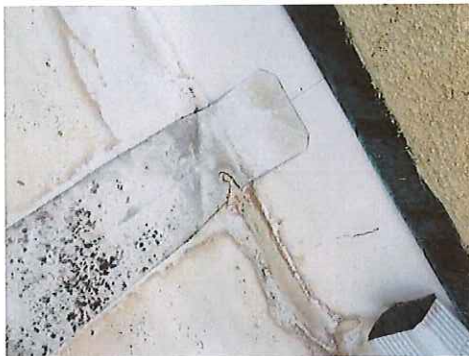
**Photo 13**

Open penetration.

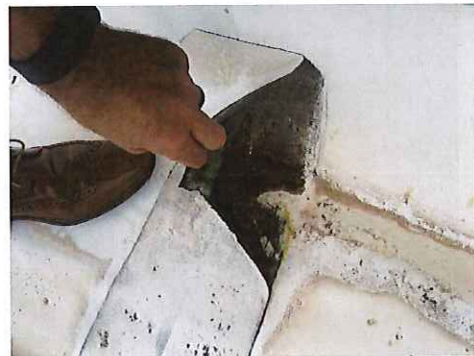
**Photo 14**

Open penetration.

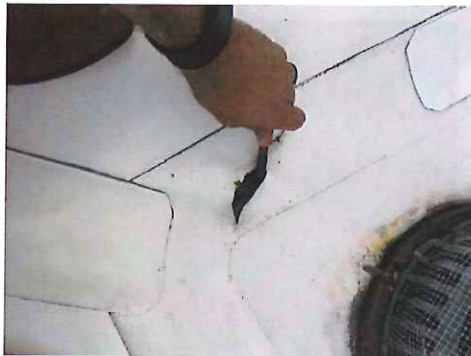
**Photo 19**

Membrane failure. Open penetration. Water intrusion onto the roof deck, insulation and interior of the building. The membrane has completely failed.

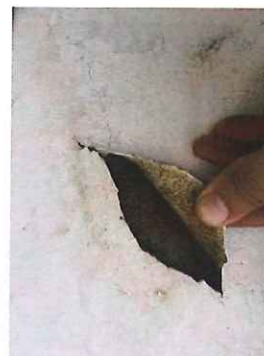
**Photo 20**

Single Ply Membrane Failure. Open penetration into the building interior.

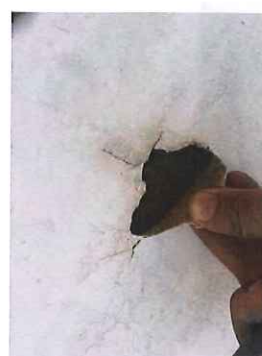
**Photo 22**

Membrane failure.

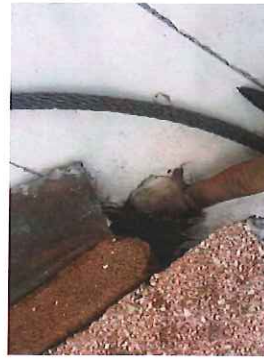
**Photo 28**

Open penetration, single ply failure

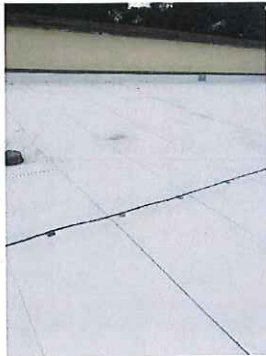
**Photo 32**

Seam failure.

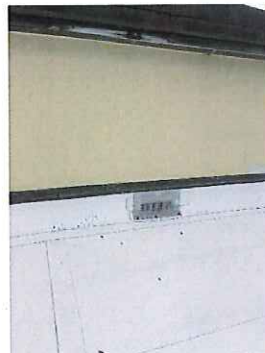
**Photo 35**

Seam deterioration.

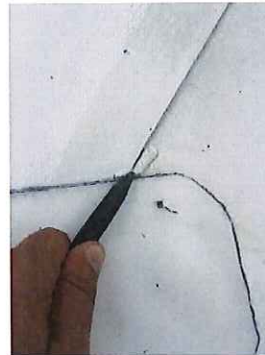
**Photo 45**

Seam Failure.

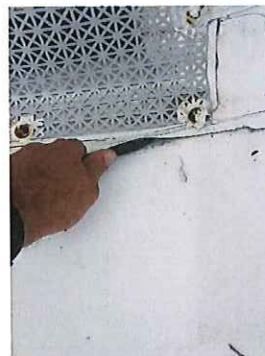
**Photo 47**

Seam failure.

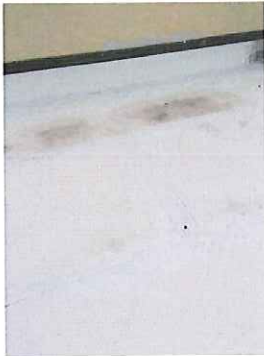
**Photo 56**

Single ply seam deterioration.

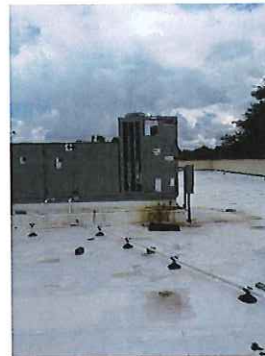
**Photo 57**

Seam failure.

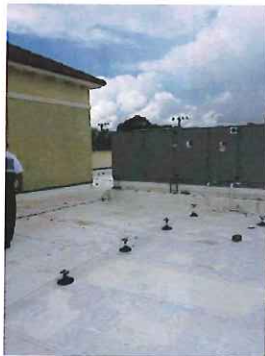
**Photo 60**

Seams coated with White Knight Plus. Proper mil thickness was not achieved. The White Knight Plus will slow down the seam deterioration but the recommended mil thickness was not met.

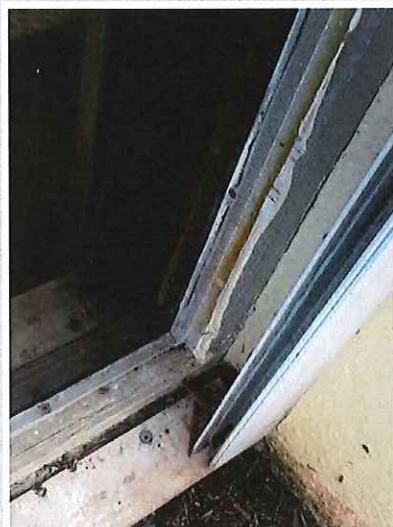
**Photo 2**

Window sealant failure.

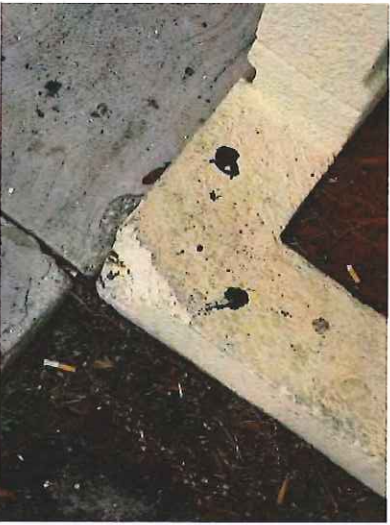
**Photo 4**

Concrete damage.

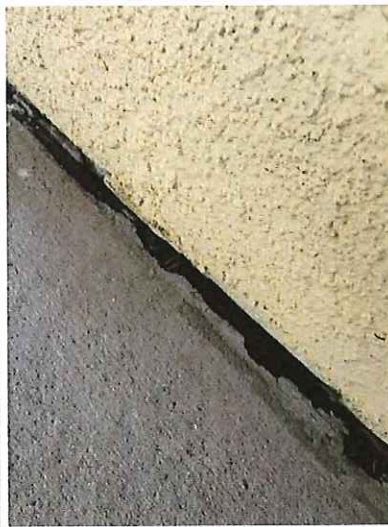
**Photo 7**

Missing joint sealant.

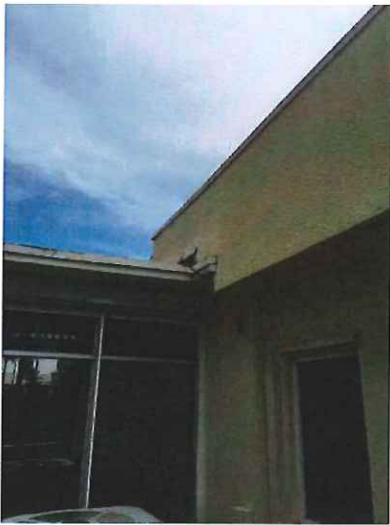
**Photo 15**

Stucco damage.

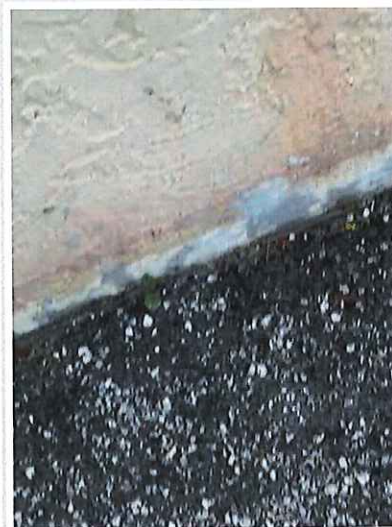
**Photo 31**

Piping not properly sealed.

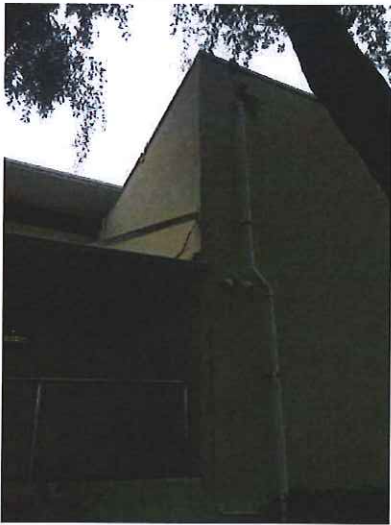
**Photo 33**

Thru wall penetration not properly sealed.

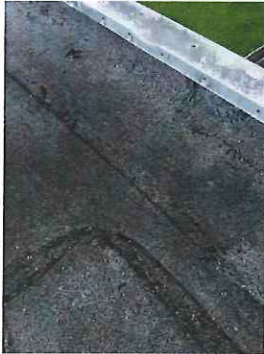
**Photo 1**

**Blisters:** Soft spongy pockets or swellings in the roofing material. They occur between layers of felt or between the roof membrane and substrate. Air or moisture vapor entrapped within a blister expands as the roof and outside air temperatures rise. This results in sufficient pressure to push the roofing felts upwards and apart. Blisters may be ruptured by roof traffic, expanding frozen water, or hail (especially during colder weather). Some blisters may become so large as to affect drainage, which may then cause ponding water. Laps could also be pulled apart, resulting in leakage. A ruptured blister will immediately allow water to penetrate and damage the roof system.

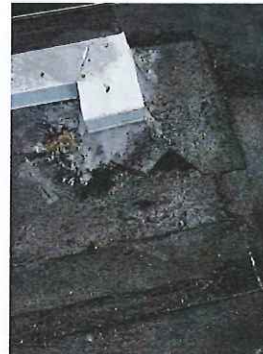
**Photo 2**

Bad detail, failing cap sheet.

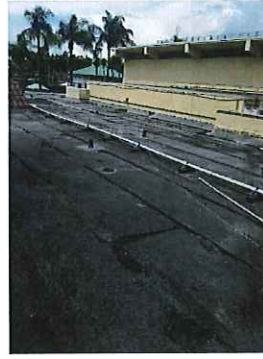
**Photo 4**

View of roof section.

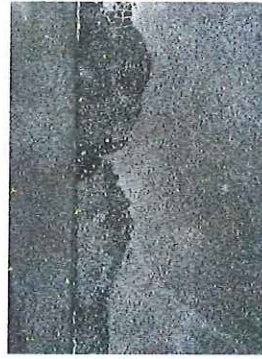
**Photo 6**

**Blisters:** Soft spongy pockets or swellings in the roofing material. They occur between layers of felt or between the roof membrane and substrate. Air or moisture vapor entrapped within a blister expands as the roof and outside air temperatures rise. This results in sufficient pressure to push the roofing felts upwards and apart. Blisters may be ruptured by roof traffic, expanding frozen water, or hail (especially during colder weather). Some blisters may become so large as to affect drainage, which may then cause ponding water. Laps could also be pulled apart, resulting in leakage. A ruptured blister will immediately allow water to penetrate and damage the roof system.

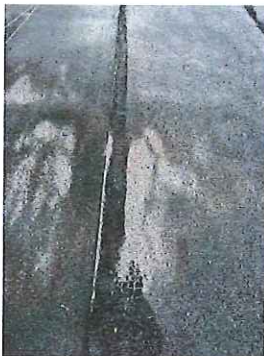
**Photo 7**

Blisters and granule loss.

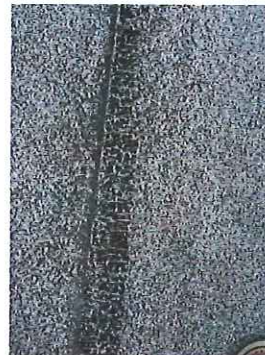
**Photo 8**

Failing seams.

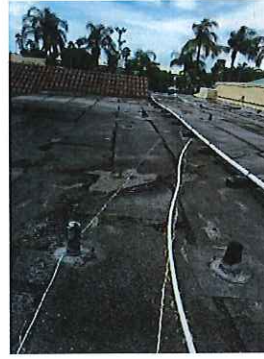
**Photo 10**

**Blisters:** Soft spongy pockets or swellings in the roofing material. They occur between layers of felt or between the roof membrane and substrate. Air or moisture vapor entrapped within a blister expands as the roof and outside air temperatures rise. This results in sufficient pressure to push the roofing felts upwards and apart. Blisters may be ruptured by roof traffic, expanding frozen water, or hail (especially during colder weather). Some blisters may become so large as to affect drainage, which may then cause ponding water. Laps could also be pulled apart, resulting in leakage. A ruptured blister will immediately allow water to penetrate and damage the roof system.

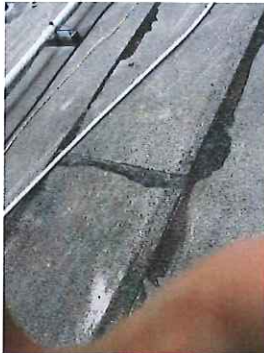
**Photo 12**

Failing seam, granule loss.

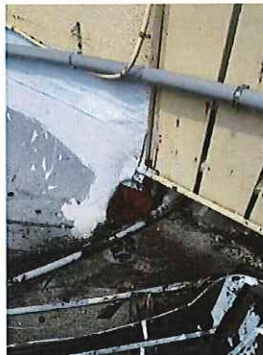
**Photo 16**

Bad details.

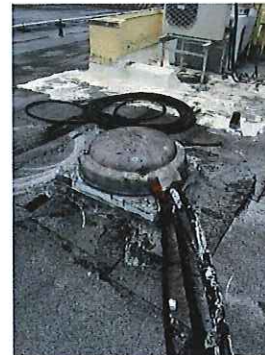
**Photo 17**

Bad detail not to code.

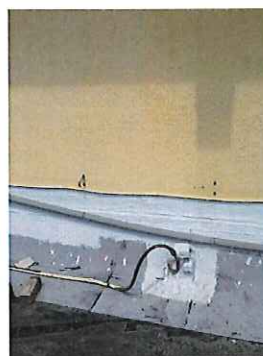
**Photo 18**

Bad detail, not to code.

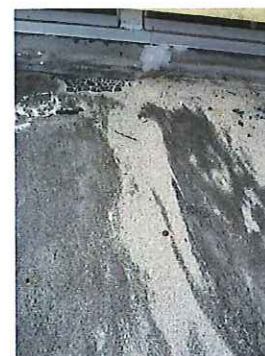
**Photo 19**

Bad detail.

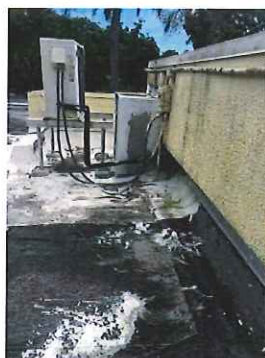
**Photo 21**

Failing membrane, ponding water.

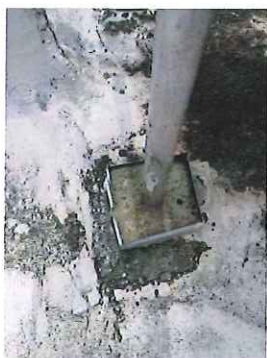
**Photo 22**

Temporary patch.

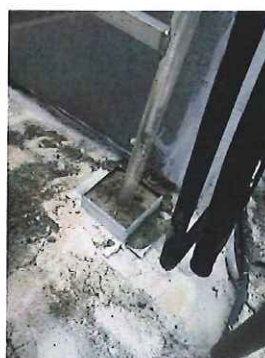
**Photo 23**

No sealant on the fast setting concrete. Pitch pocket was never completed.

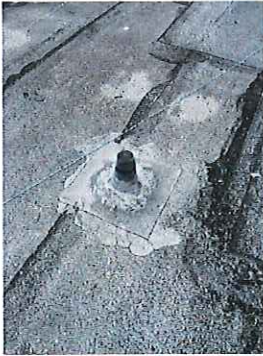
**Photo 28**

Open penetrations.

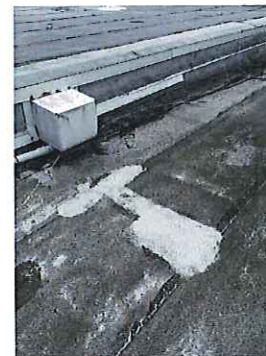
**Photo 31**

Previously repaired section.

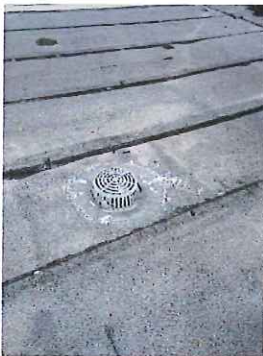
**Photo 34**

Improper detail. Membrane has been replaced.

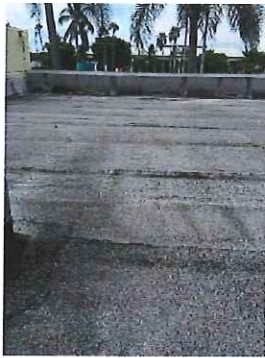
**Photo 38**

**Blisters:** Soft spongy pockets or swellings in the roofing material. They occur between layers of felt or between the roof membrane and substrate. Air or moisture vapor entrapped within a blister expands as the roof and outside air temperatures rise. This results in sufficient pressure to push the roofing felts upwards and apart. Blisters may be ruptured by roof traffic, expanding frozen water, or hail (especially during colder weather). Some blisters may become so large as to affect drainage, which may then cause ponding water. Laps could also be pulled apart, resulting in leakage. A ruptured blister will immediately allow water to penetrate and damage the roof system.

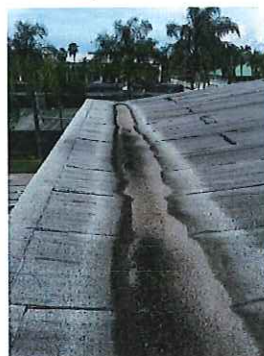
**Photo 58**

Improper detail, not to code.

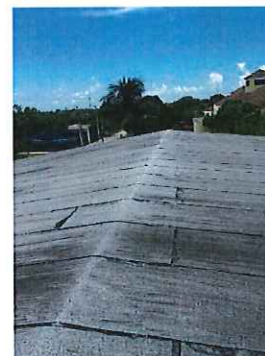
**Photo 59**

Granule loss.

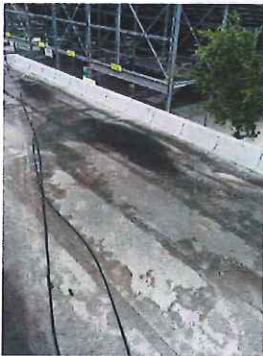
**Photo 62**

Heavy granule loss, ponding water.
